COASTAL COMMAND REVIEW

November 1943

Vol. II, No. 7

HEADQUARTERS,
COASTAL COMMAND
ROYAL AIR FORCE

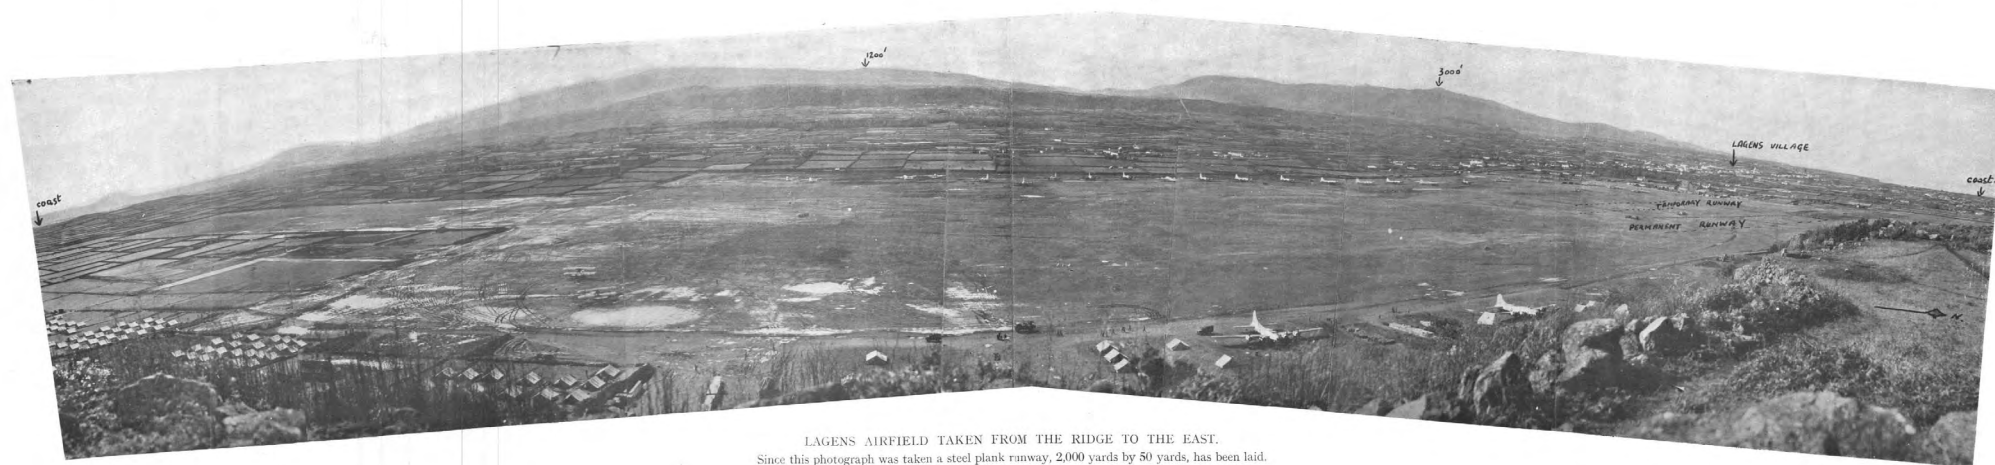
LAGENS AIRFIELD TAKEN FROM THE RIDGE TO THE EAST.
 Since this photograph was taken a steel plank runway, 2,000 yards by 50 yards, has been laid.
 (See letterpress, page 17.)

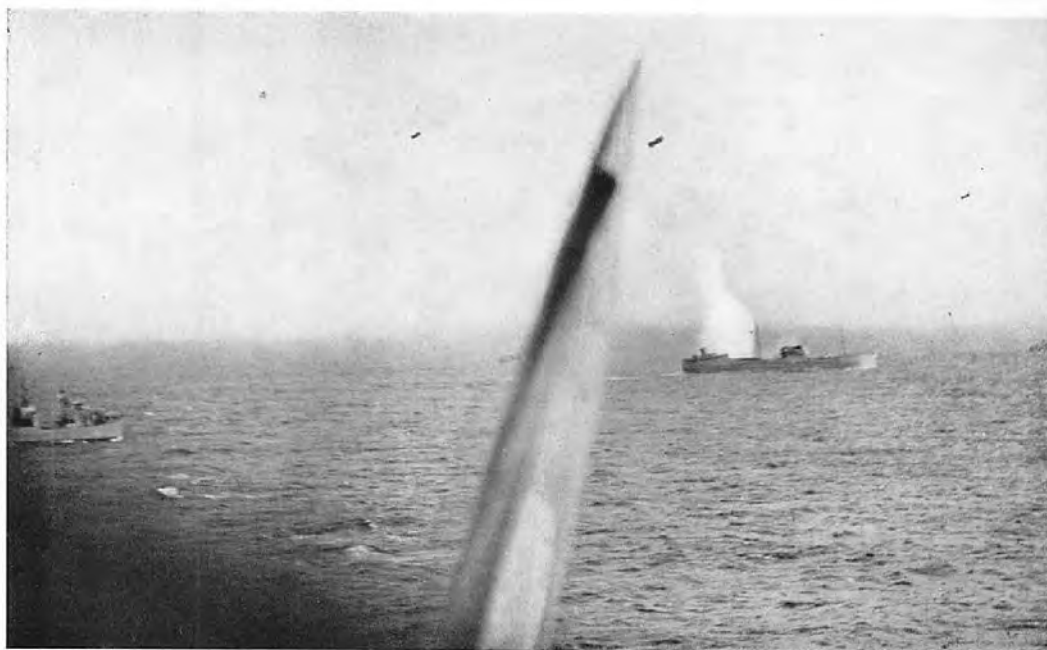
A torpedo hit on a 6,500 ton Etrema type tanker during an attack by Beaufighters of 254 and 236 Squadrons on November 23, off Texel. The tilt of the poop relative to the remainder of the ship suggests that her back is broken, and she may well be a total loss. This is the second time that this ship has been torpedoed by Coastal Command aircraft, having been hit and severely damaged by Hampdens of 489 Squadron in April. After the earlier attack she lay in Bergen for some time with a large hole in her side, before being sent to Hamburg for repairs. She remained there until October, so the attack illustrated above may well have been one of her first since returning to service.

Of the four torpedoes aimed, two were seen to hit the tanker. Two large explosions followed and it is thought that the tanker's back was broken. Thus 50 per cent. of the torpedoes found their mark, reflecting great credit on the skill and determination of the torpedo pilots.

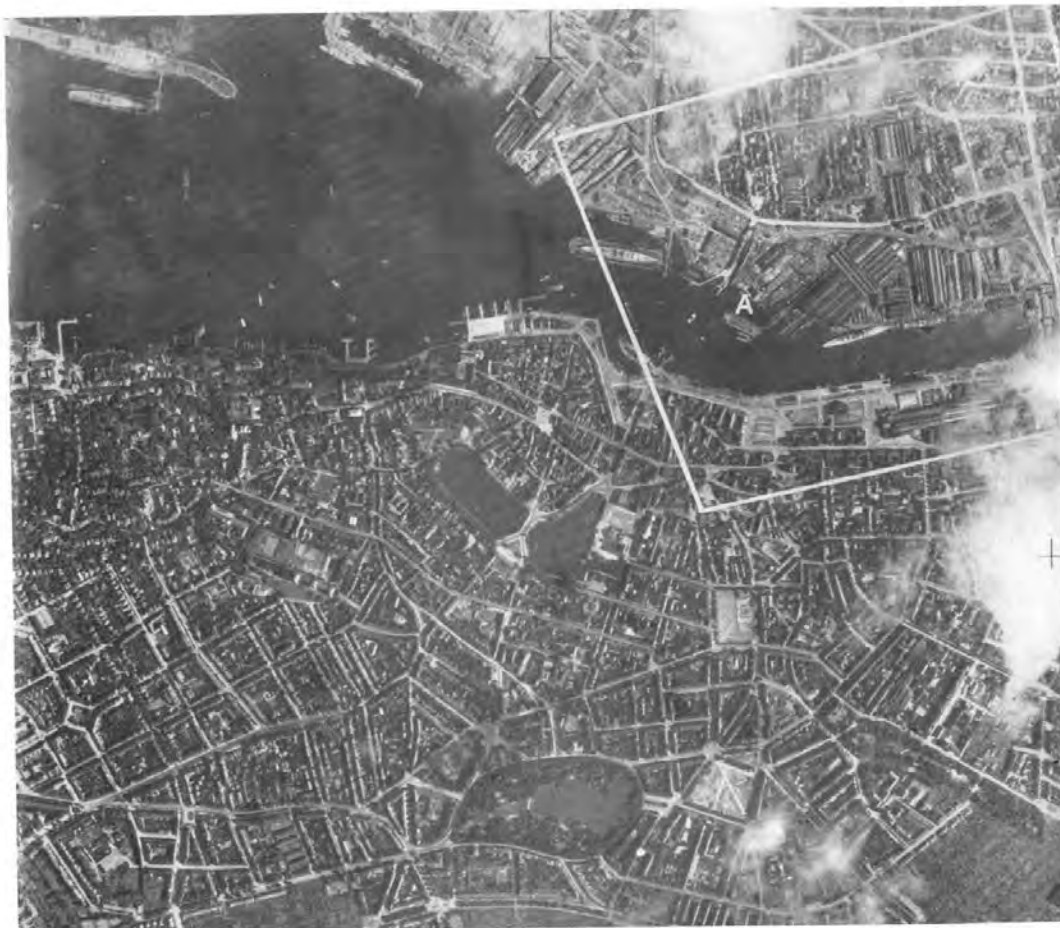
SHIPBUILDING YARDS, KIEL. Note size of *Prinz Eugen* alongside quay and of the battle cruiser in floating dock. Taken with 14" focal length camera, August, 1940. See letterpress, page 20.

Interpreters found another difficulty at the beginning of the war, when photographic prints were small. The superstructure of naval units could not be seen in these small prints and we had to rely on the length of ships to identify them. Mistakes were made and on one occasion, it will be remembered, 70 U-Boats were reported to be at Emden. When better prints were made, it was found that the U-Boats were only harmless commercial barges, of exactly the same length as one type of U-Boat. This source of error was mostly removed when the 20-in. and, later, the 36-in. focal length camera were introduced. On March 12, 1941, when a sortie over Kiel was covered by 20-in. focal length cameras, it was realized how much detail had been lost by the old method. For the first time it was possible to assess the number of U-Boats being built. An extract from one report, on a sortie over a shipbuilding yard, reveals the advantages that came with this improvement. The report stated, "What have previously been thought to be 11 mine sweepers under construction at these yards can now definitely be defined from these photographs to be U-Boats." A report on another yard photographed by the 20-in. focal length camera stated, "It has been assumed that U-Boats are being constructed and fitted out under cover at these yards, but now these excellent photographs show an additional seven being constructed in-the open, on the building slips."

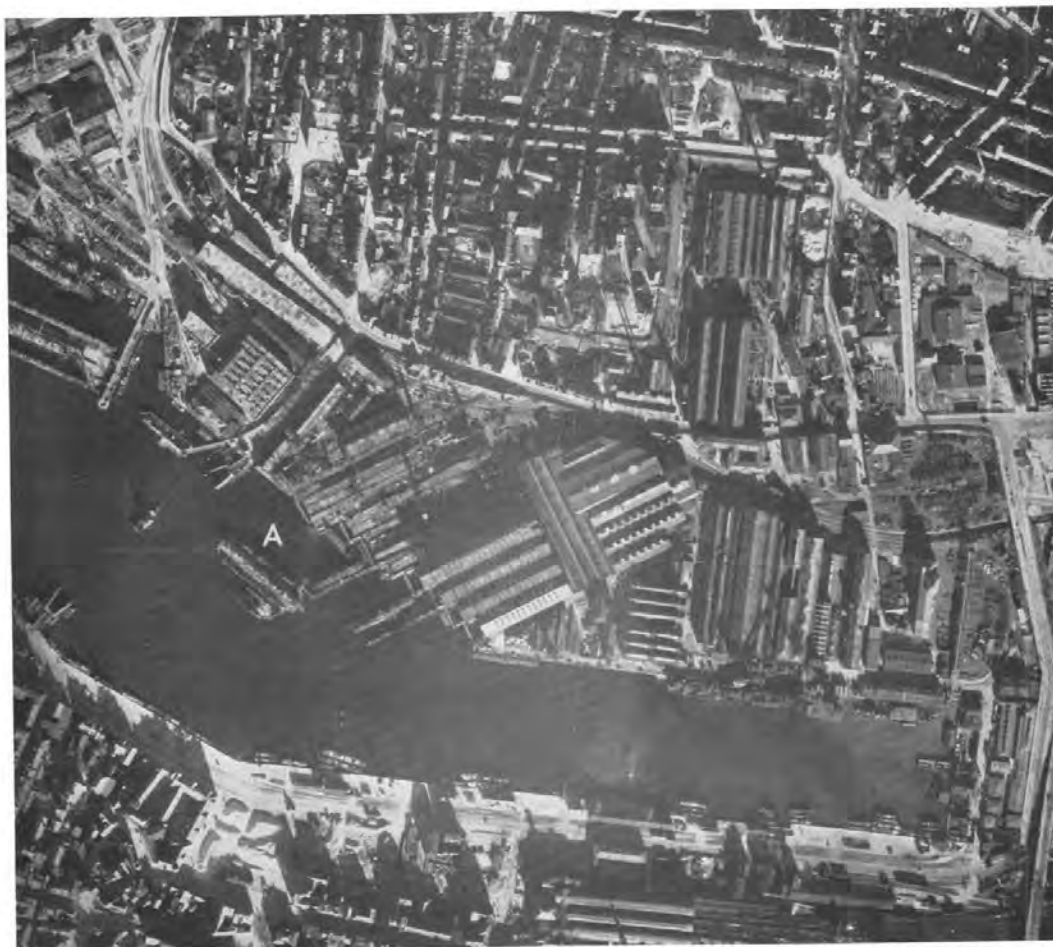
This photograph covers the same area as is enclosed in the white lines in the photograph at the top of the page. Showing increased scale and quality obtained with 36" focal length camera. Taken April 20, 1943. Note comparative size of floating dock "A" in the two photographs.

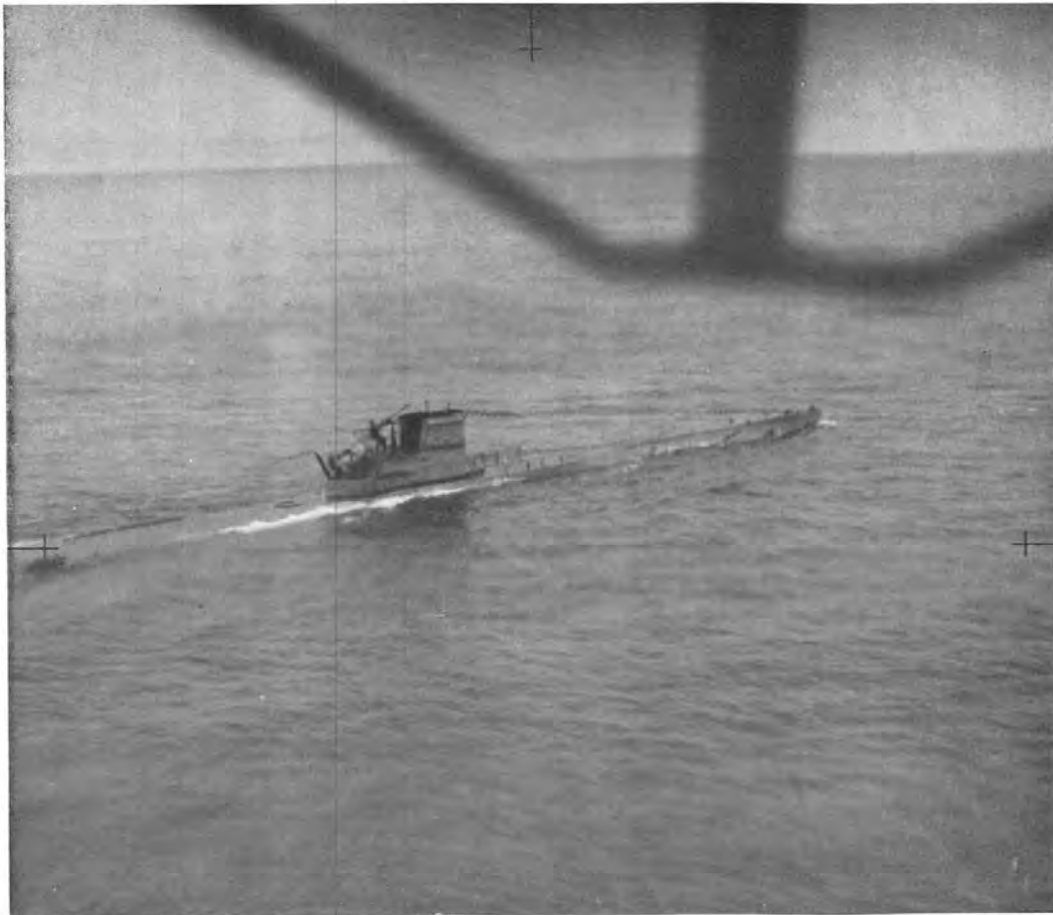
A 500-ton U-Boat with re-designed conning tower, carrying 20-mm. guns. The first photograph to reveal substitution of increased A.A. armament for 88-mm. guns. See letterpress, page 20.

Coastal Command has obtained many excellent oblique photographs and these have yielded information which could never have been deduced from the best vertical photographs that could be taken. The armament of the broad beam type of U-Boat was first identified on obliques taken by Coastal Command and other photographs, also by the Command, have yielded the first information about the new and unidentified armament with which U-Boats are now being equipped.

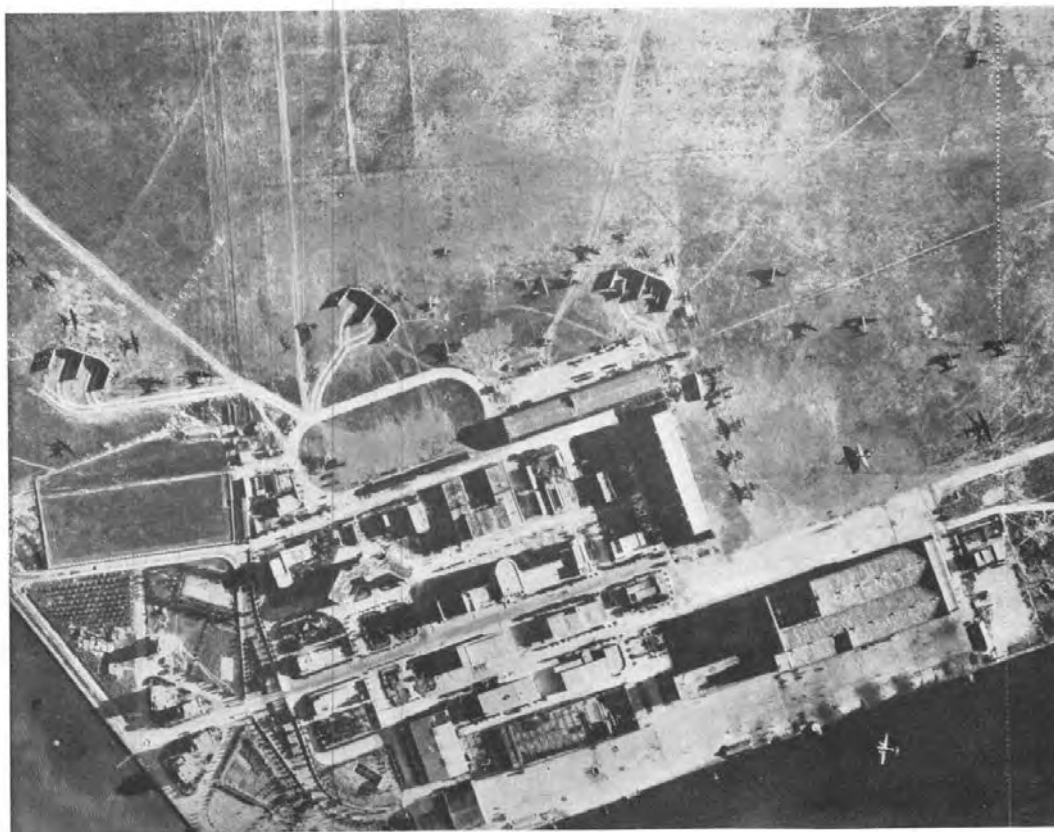
CAGLIARI AIRFIELD. This photograph illustrates profile shadows of aircraft, indicating dihedral, engine nacelle shapes, etc.

engines) and the position of dorsal turrets. Measurements are now made so accurately that new types of aircraft are recognized before ground reports have been received. The F.W.190 and the Me.323 were first measured on air photographs and when these types of aircraft were afterwards captured it was found that these measurements were remarkably accurate. The wing span of the F.W.190 had been correct within 1 foot and there was less than 3 feet difference in the Me 323.

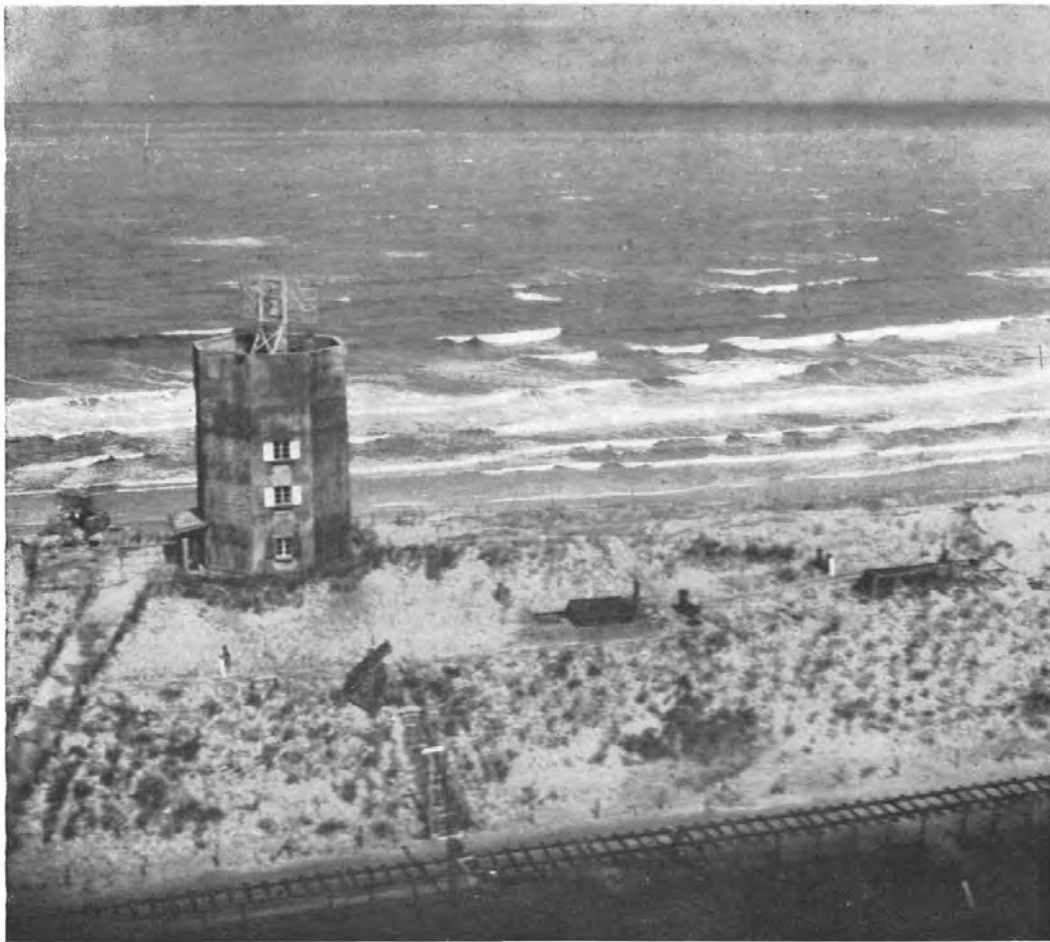
Coast Watching Radar Station at Hook of Holland, showing details of frame aerial array from which it is possible to discover the type of emissions which this station sends out. It would not be possible to find this out from vertical photographs. See letterpress, pages 20-21.

An occasional oblique photograph is indispensable in the study of small-scale objects such as wireless installations. Much of the modern apparatus is so complex that no vertical photograph could give full details. For example, an oblique of a wireless installation at Anderville supplied the first proof that the Germans were using radio detection against our aircraft. By measuring the aerial arrays, data on the probable frequencies was obtained, and by studying the

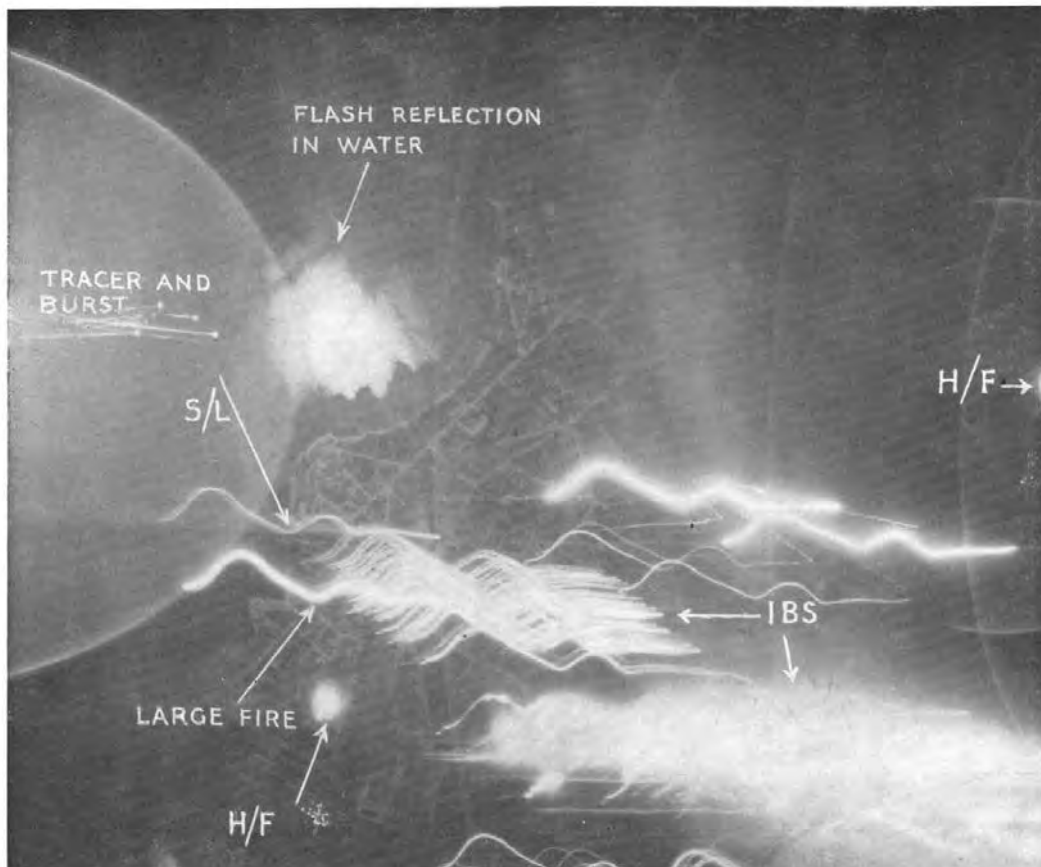
Night photograph showing ground detail illuminated by flash bomb, Searchlights (S/L), the tracks made by incendiary bombs (IBS), and flashes from a heavy Flak battery (H/F). See letterpress, page 21.

In many ways night and day photographs are complementary, for the one often indicates where to look for damage on the other. And by comparing them they sometimes show exactly where a heavy bomb has exploded, thus making it possible to assess the damage done by bombs of different calibre.

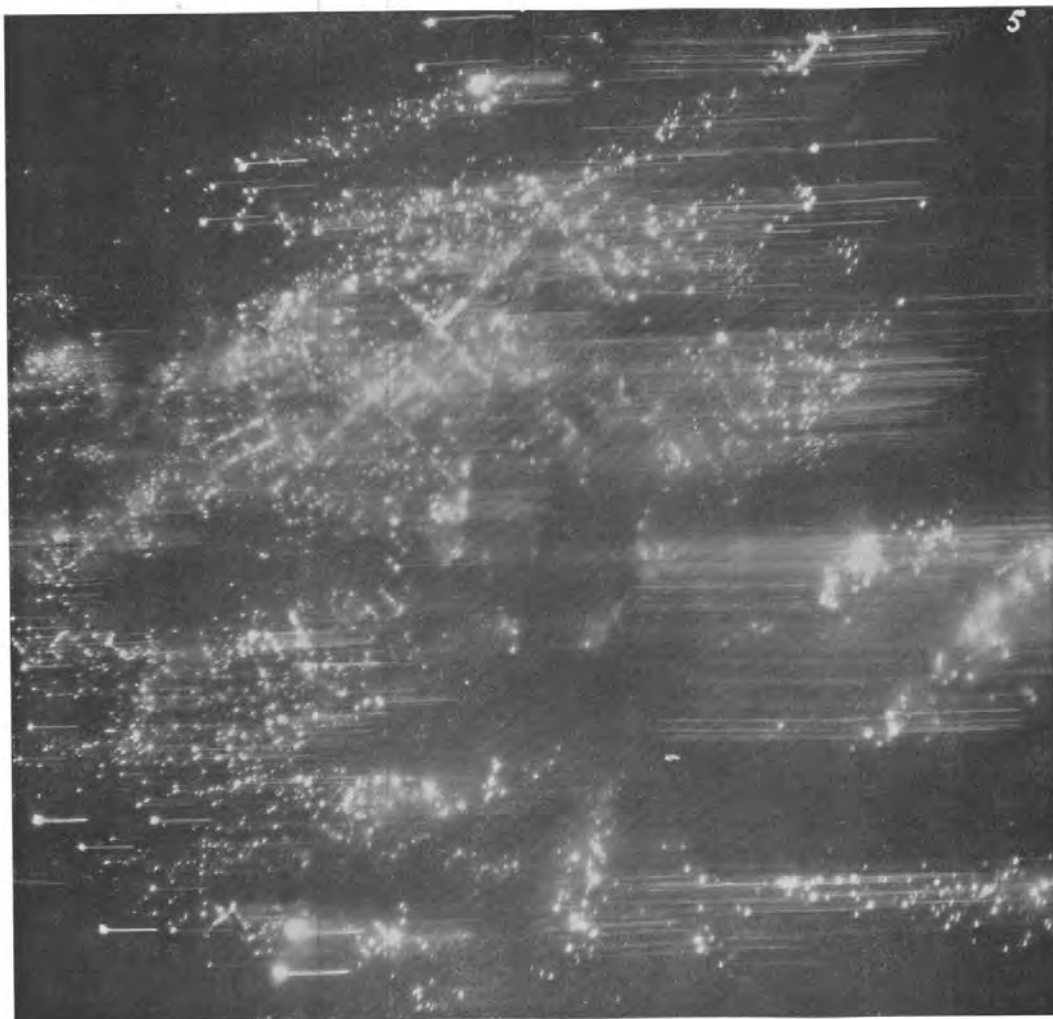
Night photograph showing light made by vast number of incendiary bombs. The pattern of the streets can be seen. Night photographs can sometimes be plotted by this means. See letterpress, page 21.

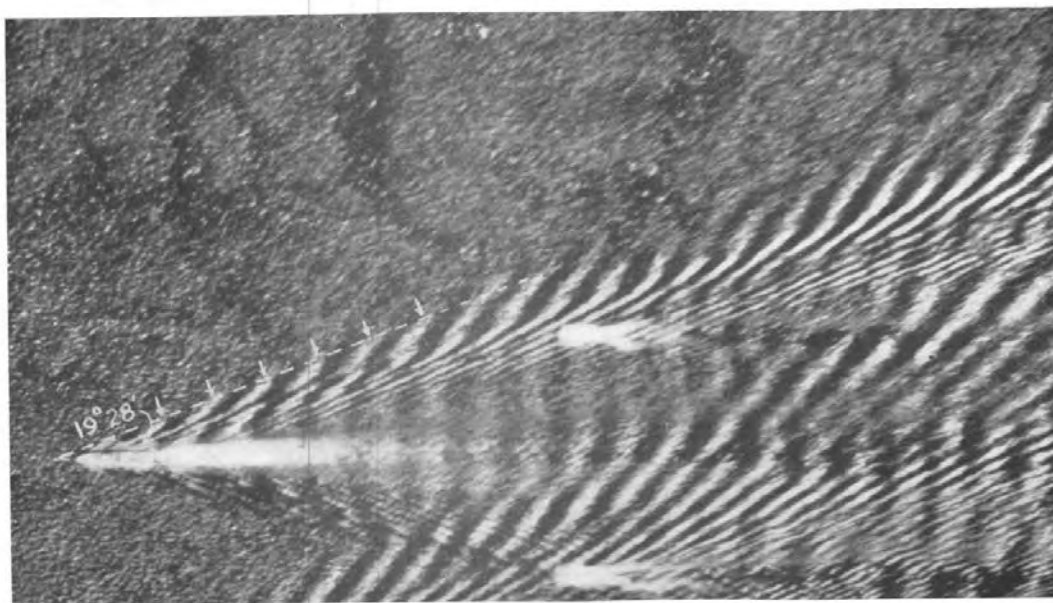
An unusually pronounced wave pattern which serves to show how easily measurements may be made to determine speed of ship. See letterpress, page 19.

contours of the surrounding area it was possible to determine the characteristics of the wave lengths.

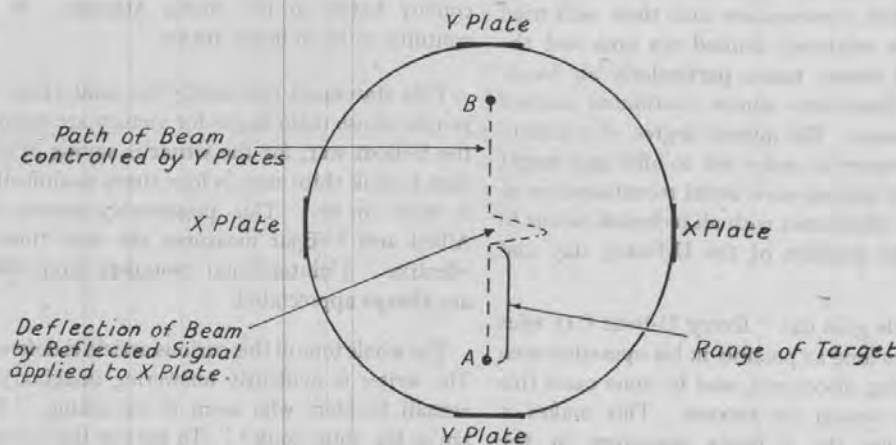
Fig. 2

It will be remembered that in our article on the Cathode Ray Tube in the *Coastal Command Review*, Vol. II, No. 5, for September, we explained how the beam could be moved up and down or from side to side by varying the voltages on the "X" and "Y" plates. Let us arrange for the beam to move from the bottom of the tube to the top by varying the voltage on the "Y" plates in the same time that it takes a signal to travel 200 miles, i.e., to a target 100 miles away and back again. If we arrange for the beam and the signal to start off simultaneously and apply the return signal to the "X" plates so that it moves the beam sideways, then we have a direct measure of the distance of the target. See Fig. 2.

Assuming that we wish the distance from "A" to "B" to represent distances of targets up to 100 miles, then the beam must move from "A" to "B" in a time which is equal to:—

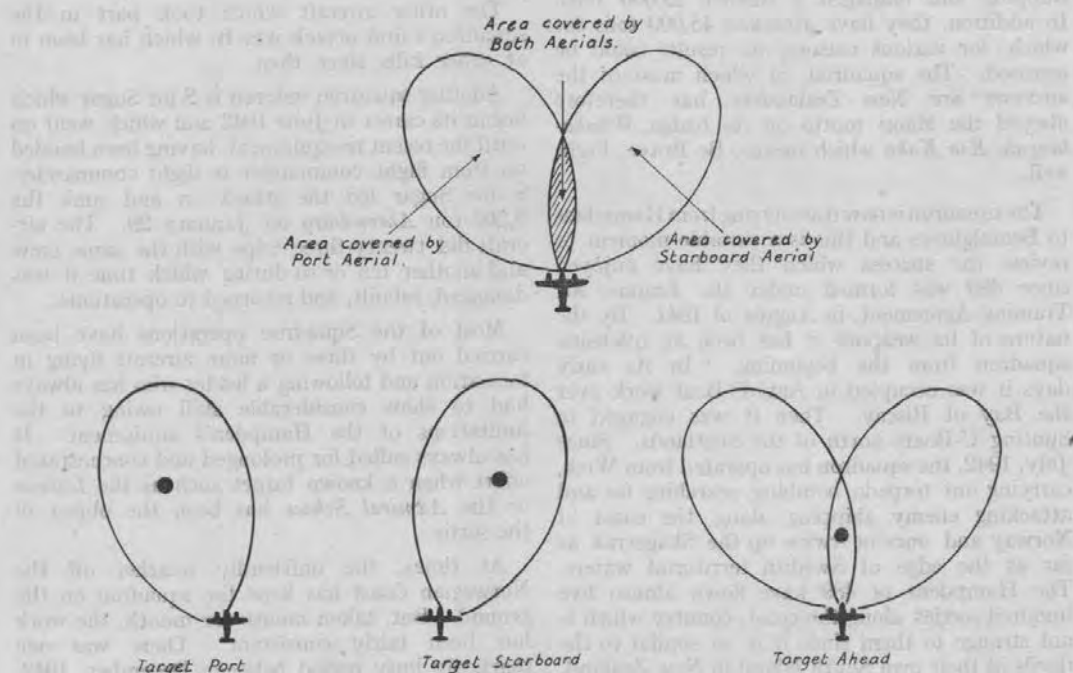
Fig. 3

of direction, i.e., we can tell whether the target is to port or starboard. We can improve on this by arranging the aerals so that there is one direction in which a signal can be received by both aerals simultaneously. See Fig. 3.

To ascertain the direction of the target the aircraft is turned until the echo is received equally well on either aerial. The most suitable direction is straight ahead as then the act of manoeuvring the aircraft to maintain equal echoes on both aerals automatically heads the aircraft in the direction of the target.

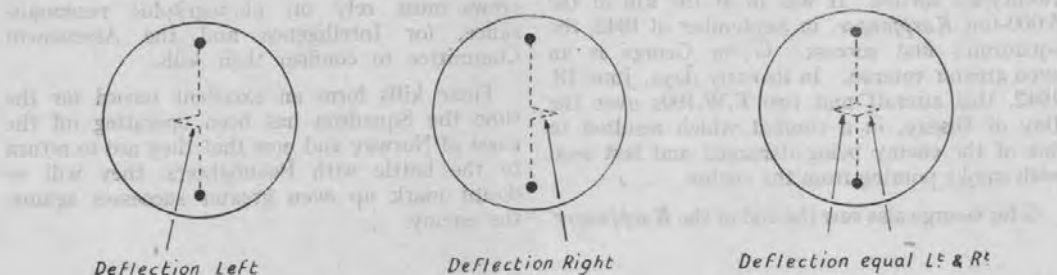
Fig. 4

aerial systems. In order to enable this comparison to be made it is necessary to switch the receiver alternately from one aerial to the other. This could be done by hand, but in practice it is arranged to be done automatically at high speed. The comparison is made easy by arranging that an echo received on the port side is shown by deflecting the Cathode Ray Beam to the left of the centre line of the Cathode Ray Tube and vice versa. See Fig. 4.
