COASTAL COMMAND REVIEW

February 1945

Vol. IV, No. 2

HEADQUARTERS,
COASTAL COMMAND
ROYAL AIR FORCE

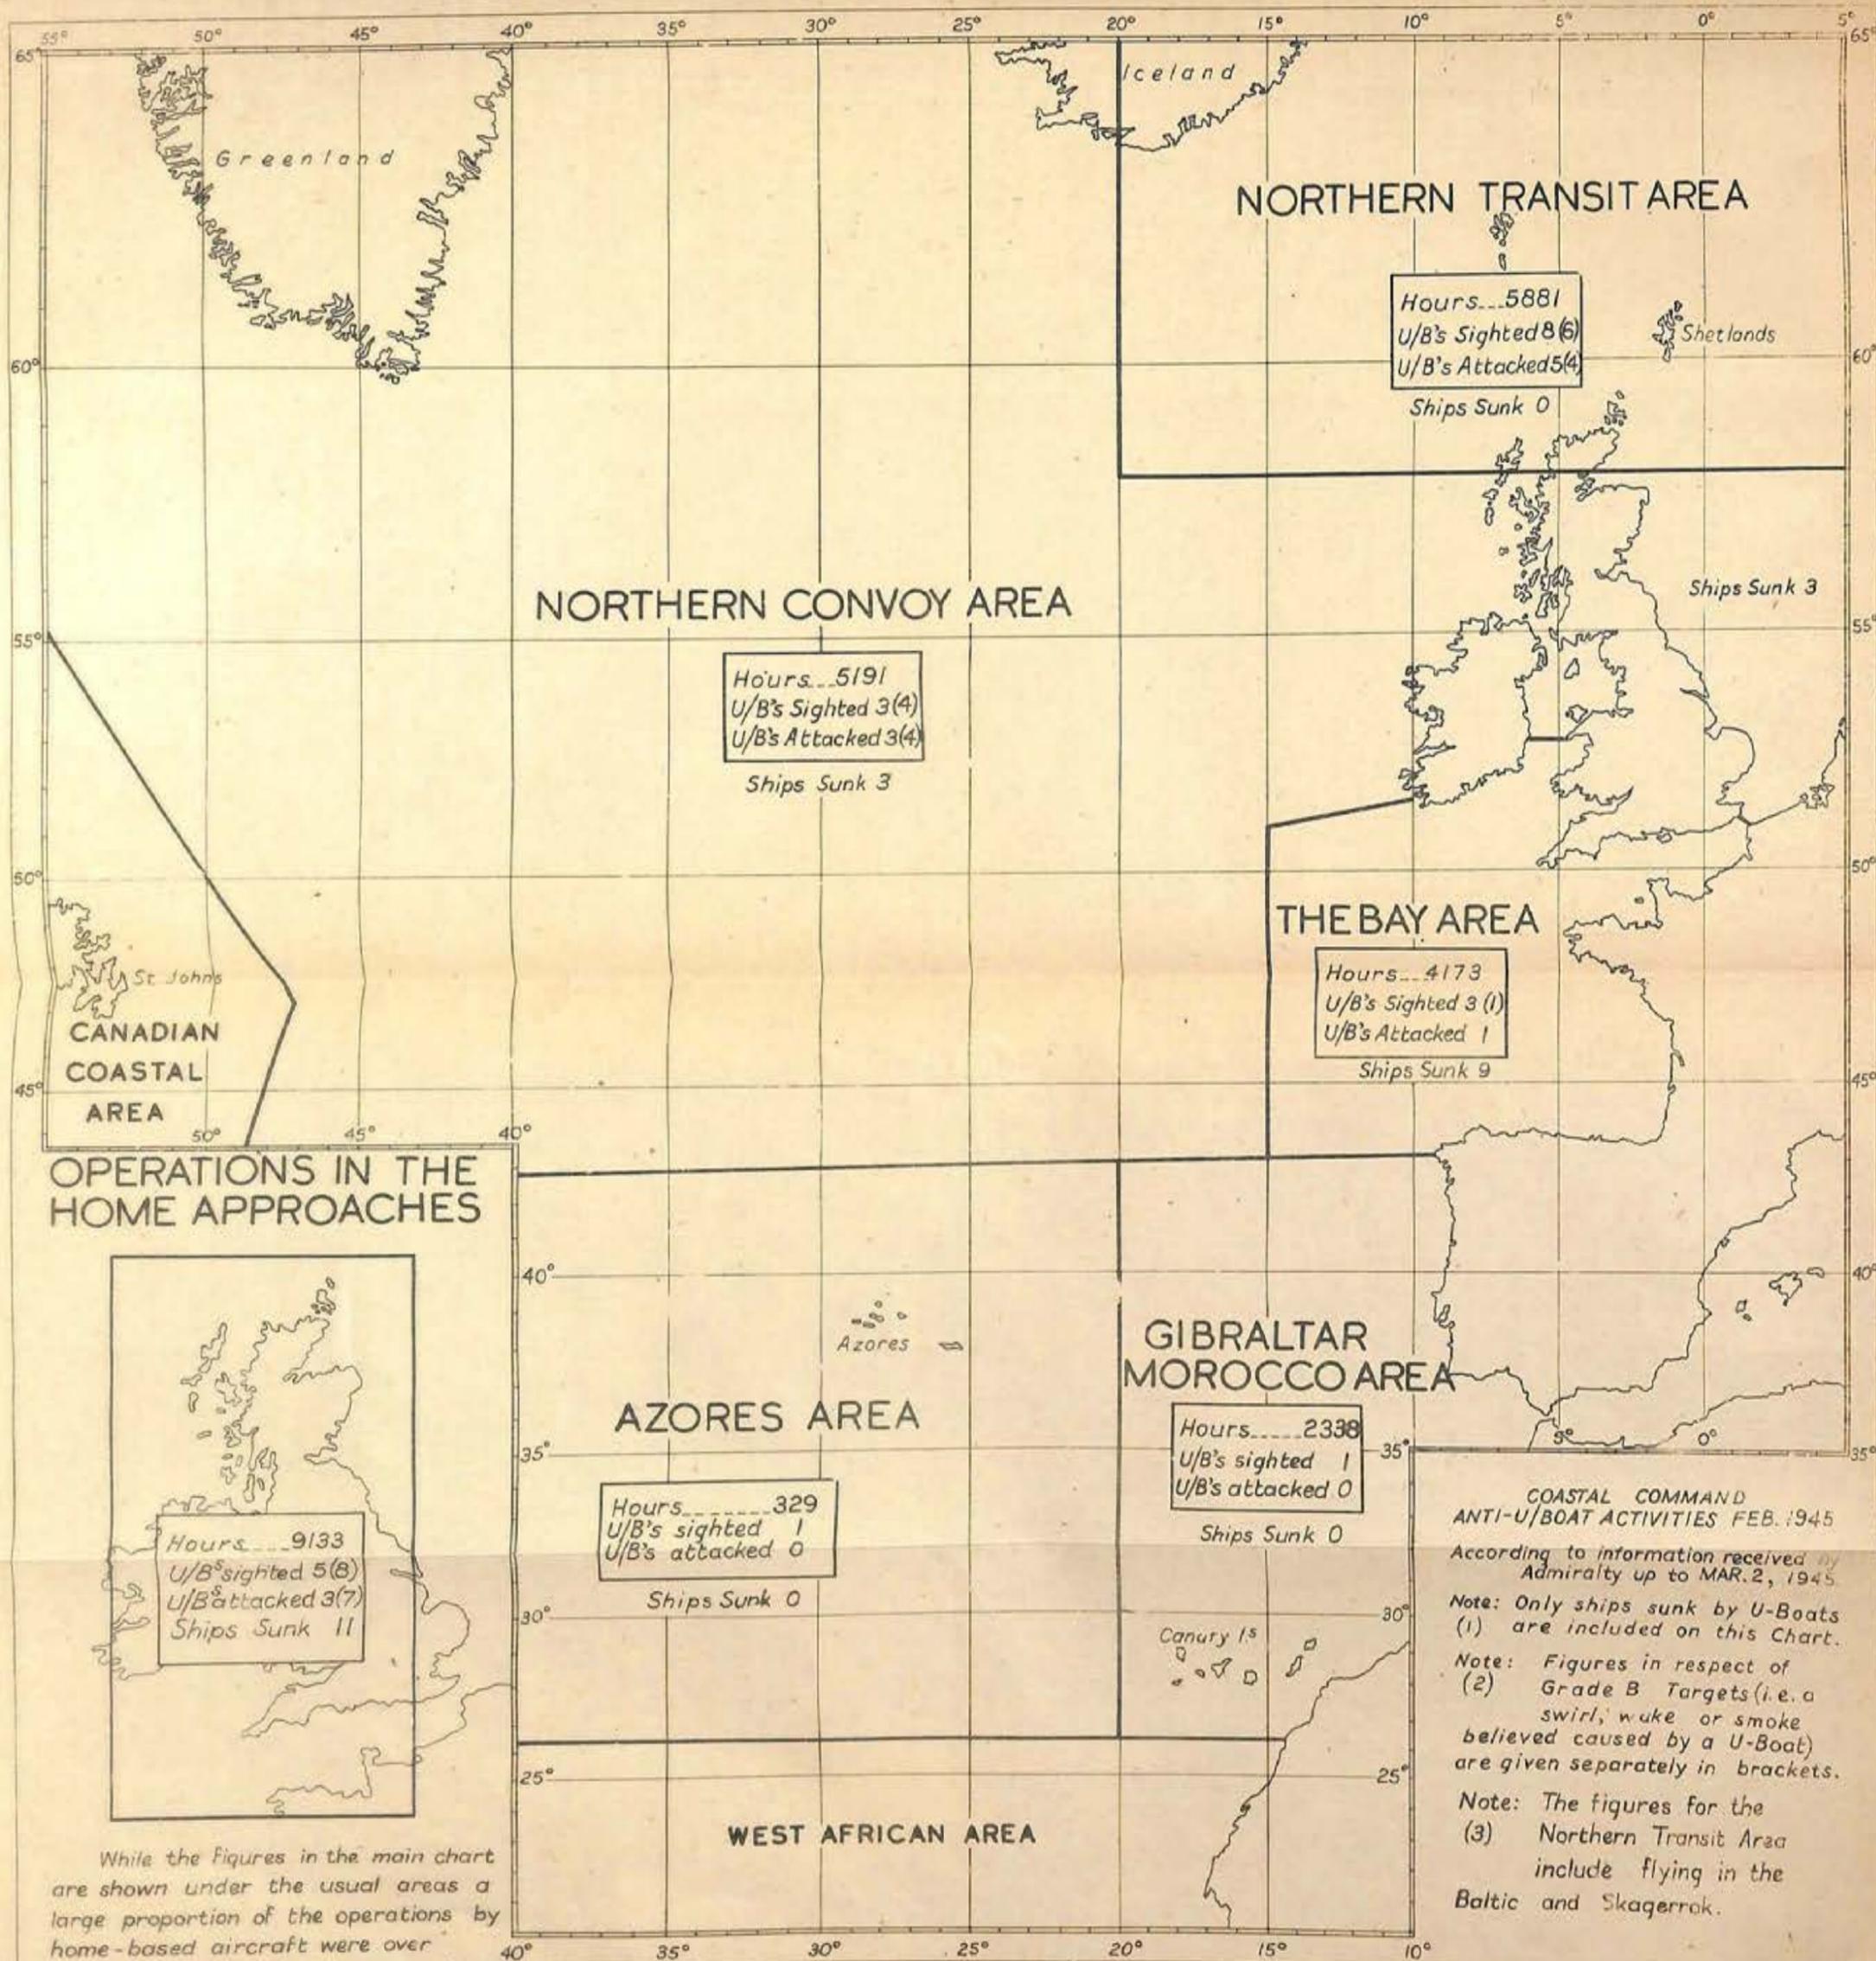
While the figures in the main chart are shown under the usual areas a large proportion of the operations by home-based aircraft were over inshore waters. To illustrate these separate (but not additional) figures are given in the inset.

COASTAL COMMAND
ANTI-U/BOAT ACTIVITIES FEB. 1945
According to information received by
Admiralty up to MAR. 2, 1945.

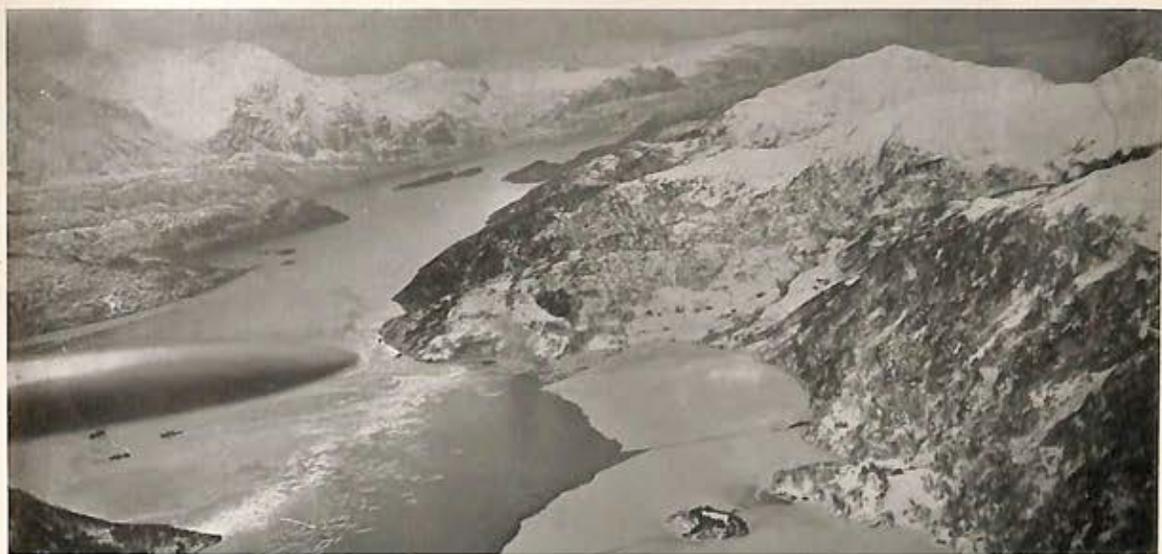
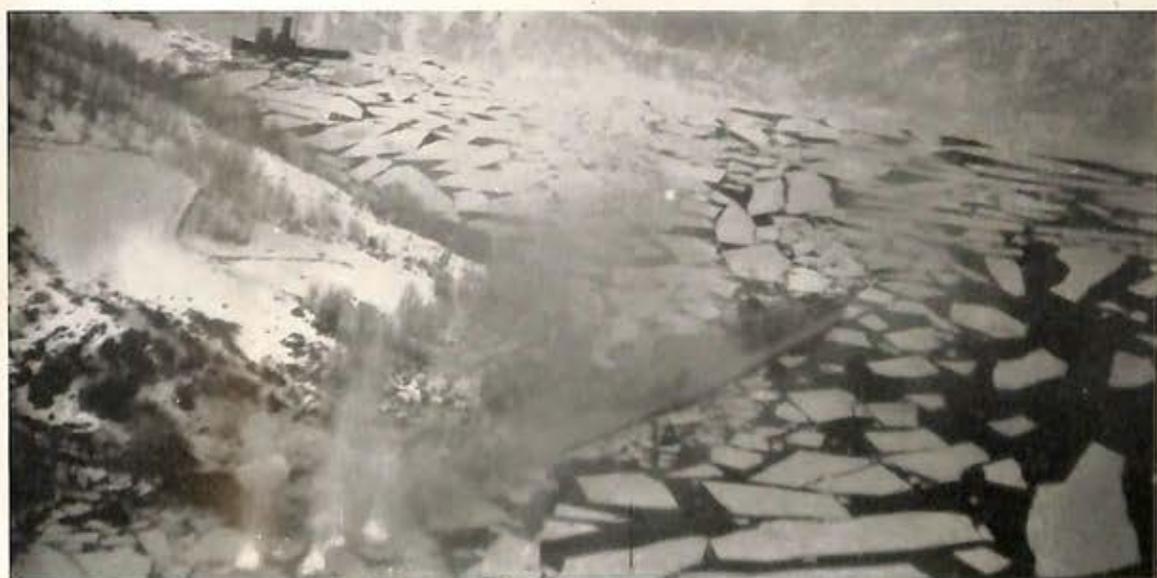
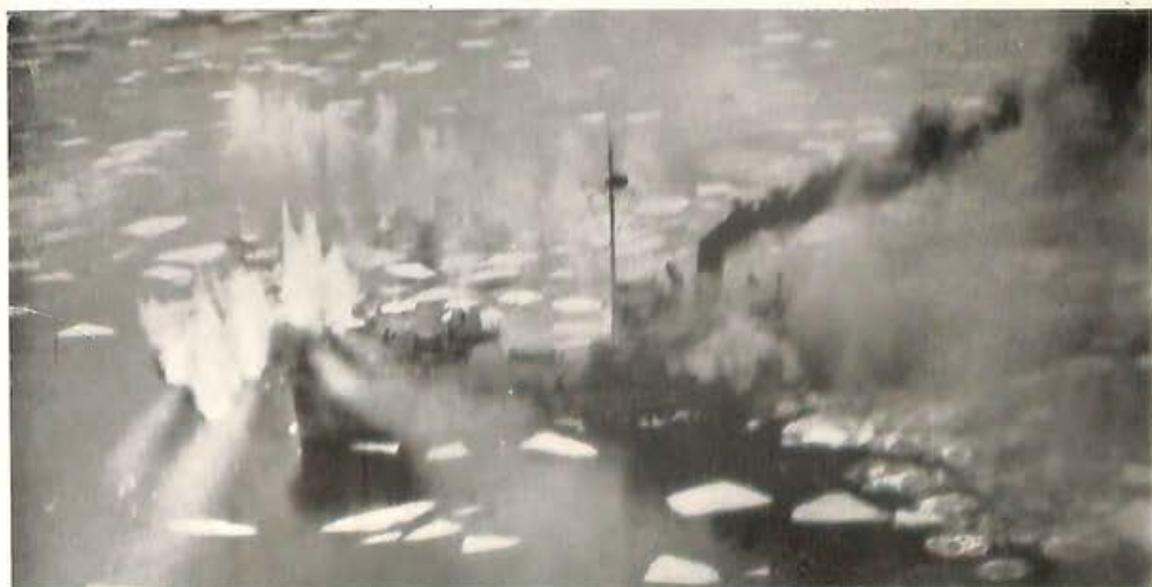
On February 9, Beaufighters of the Dallachy Wing attacked a "Narvik" class destroyer which was lying up in the inaccessible Fordefjord. The difficult terrain can be clearly seen in the photographs. The destroyer and two trawler type auxiliaries were damaged. In the middle of the top photograph the destroyer can be seen lying close into the headland. The middle photograph shows the destroyer half hidden by smoke. (See letterpress, page 11.)

On February 9, 30 Beaufighters from Dallachy sighted a Narvik class destroyer and several other vessels in Fordefjord (see Plate 1). The fjord is narrow and is flanked by steep hills, consequently it was impossible for all the Beaufighters to attack together. The ships and land batteries put up an intense flak barrage, through which all the aircraft had to fly. Nevertheless, the Wing attacked, and damaged the destroyer and two trawler type auxiliaries. Six of our aircraft were shot down by flak, and a further three were destroyed by enemy fighters, who intercepted the Beaufighters as they broke away from the attack. S/404 put up a fine performance by destroying one F.W.190 and damaging another.

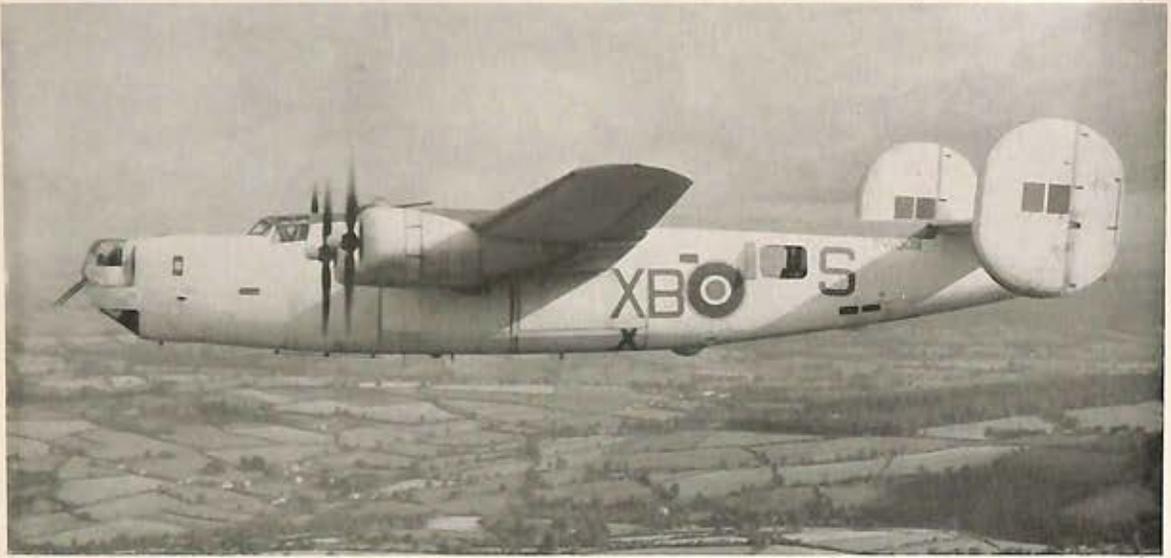
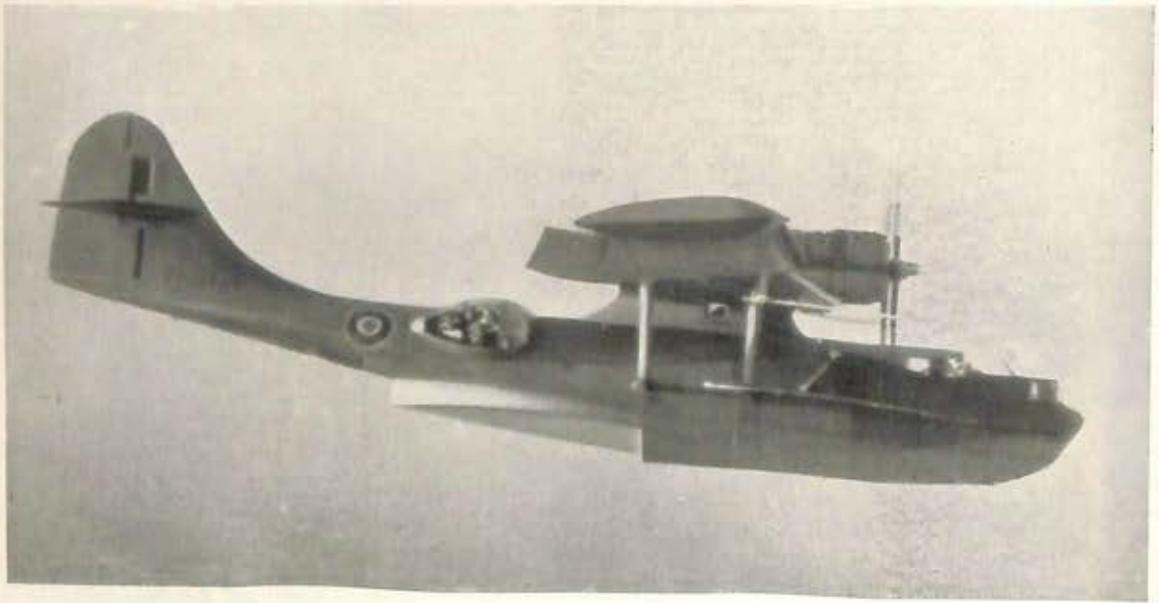
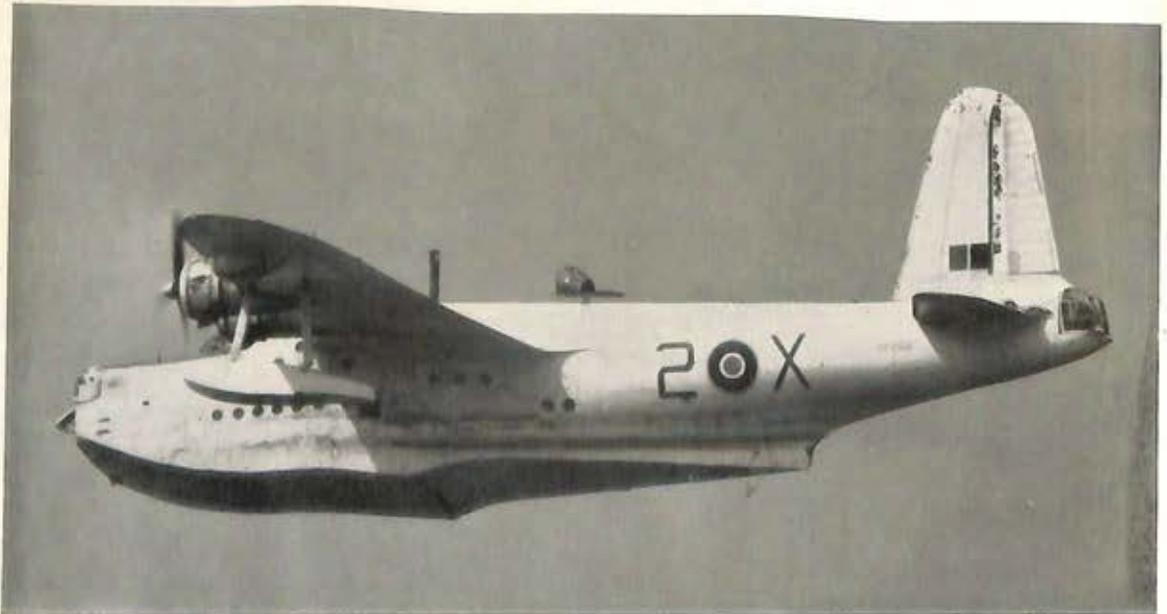
The top photograph gives a side view of a Liberator, the excellent facilities of this beam lookout position have never been fully used by visual lookouts. In the middle photograph of a Catalina it can be seen how the flight engineer can make a valuable addition to the beam lookout from his window. A number of sightings have been made by the lookouts from the galley hatch of Sunderlands. A side view of one is shown in the bottom photograph. (See letterpress, page 24.)

Unfortunately the design of the aircraft is such that the beam lookout is unlikely to be very active unless a special effort is made to overcome the difficulties.

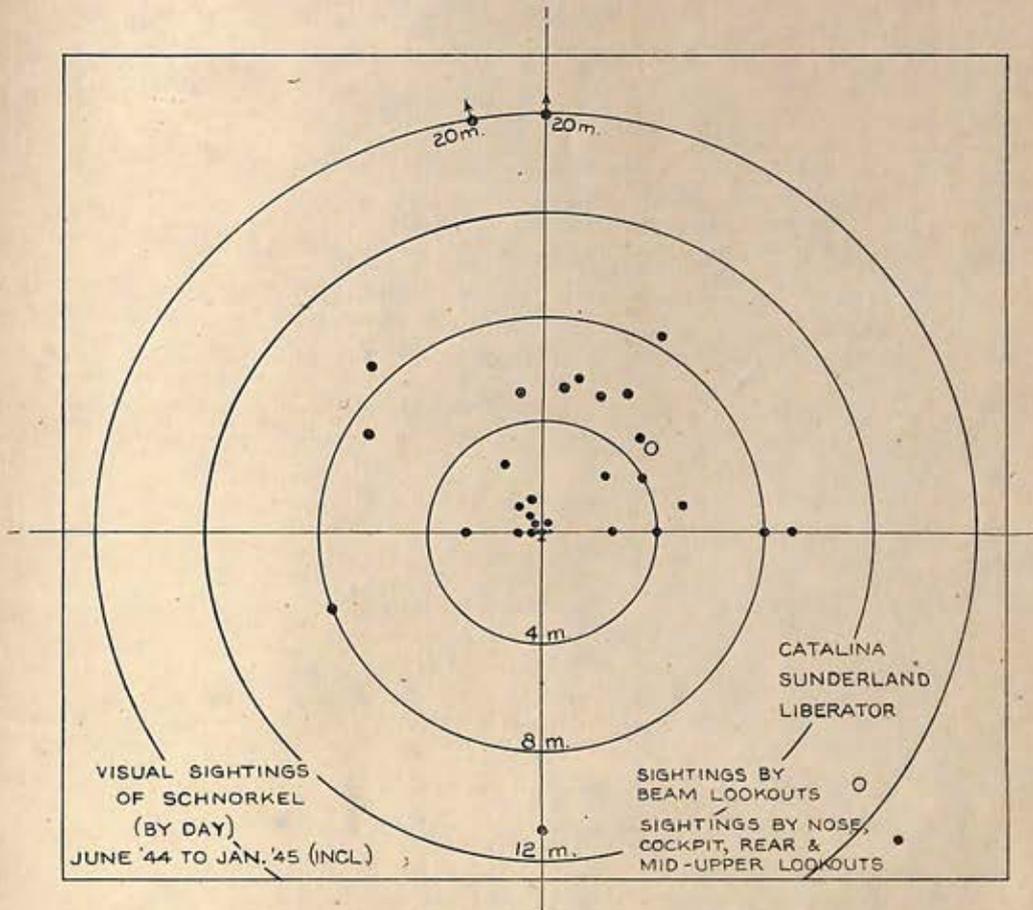
Figure 2

In the Catalina, the blister is the principal lookout position on the beam. The flight engineer can keep a watch in this direction, though proper scanning is difficult from his position. In spite of this, many objects on the sea have been sighted by the flight engineer which otherwise would have been missed.
